3. INTERMEDIATE FIELD TEST 1

3.1 TEST 1 OBJECTIVES AND TEST PIT OVERVIEW

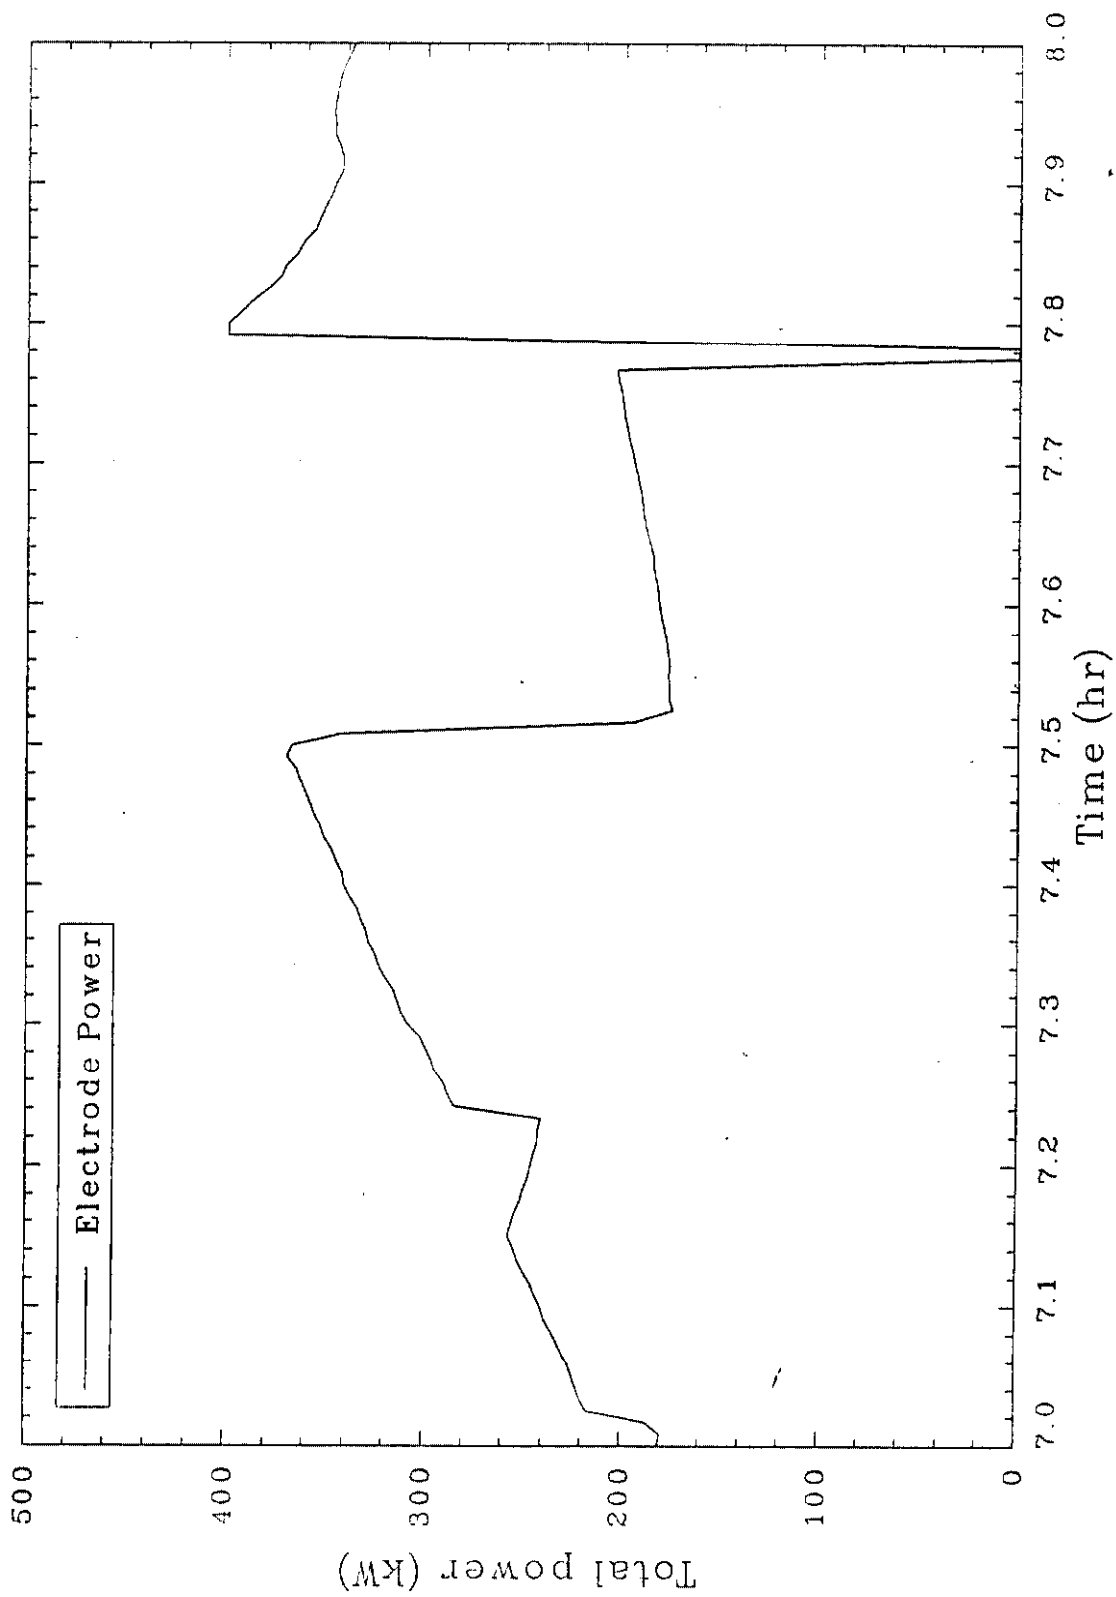
370 to 180 kW as a result of the event; this loss of power is illustrated in Figure 47. Radiant heat losses from the molten glass resulted in increased resistance in the molten glass as the glass cooled. This phenomenon occurred during essentially all gas releases (see Figure 23, p. 58).

Figure 47. Total electrode power for the third event in Test 1.

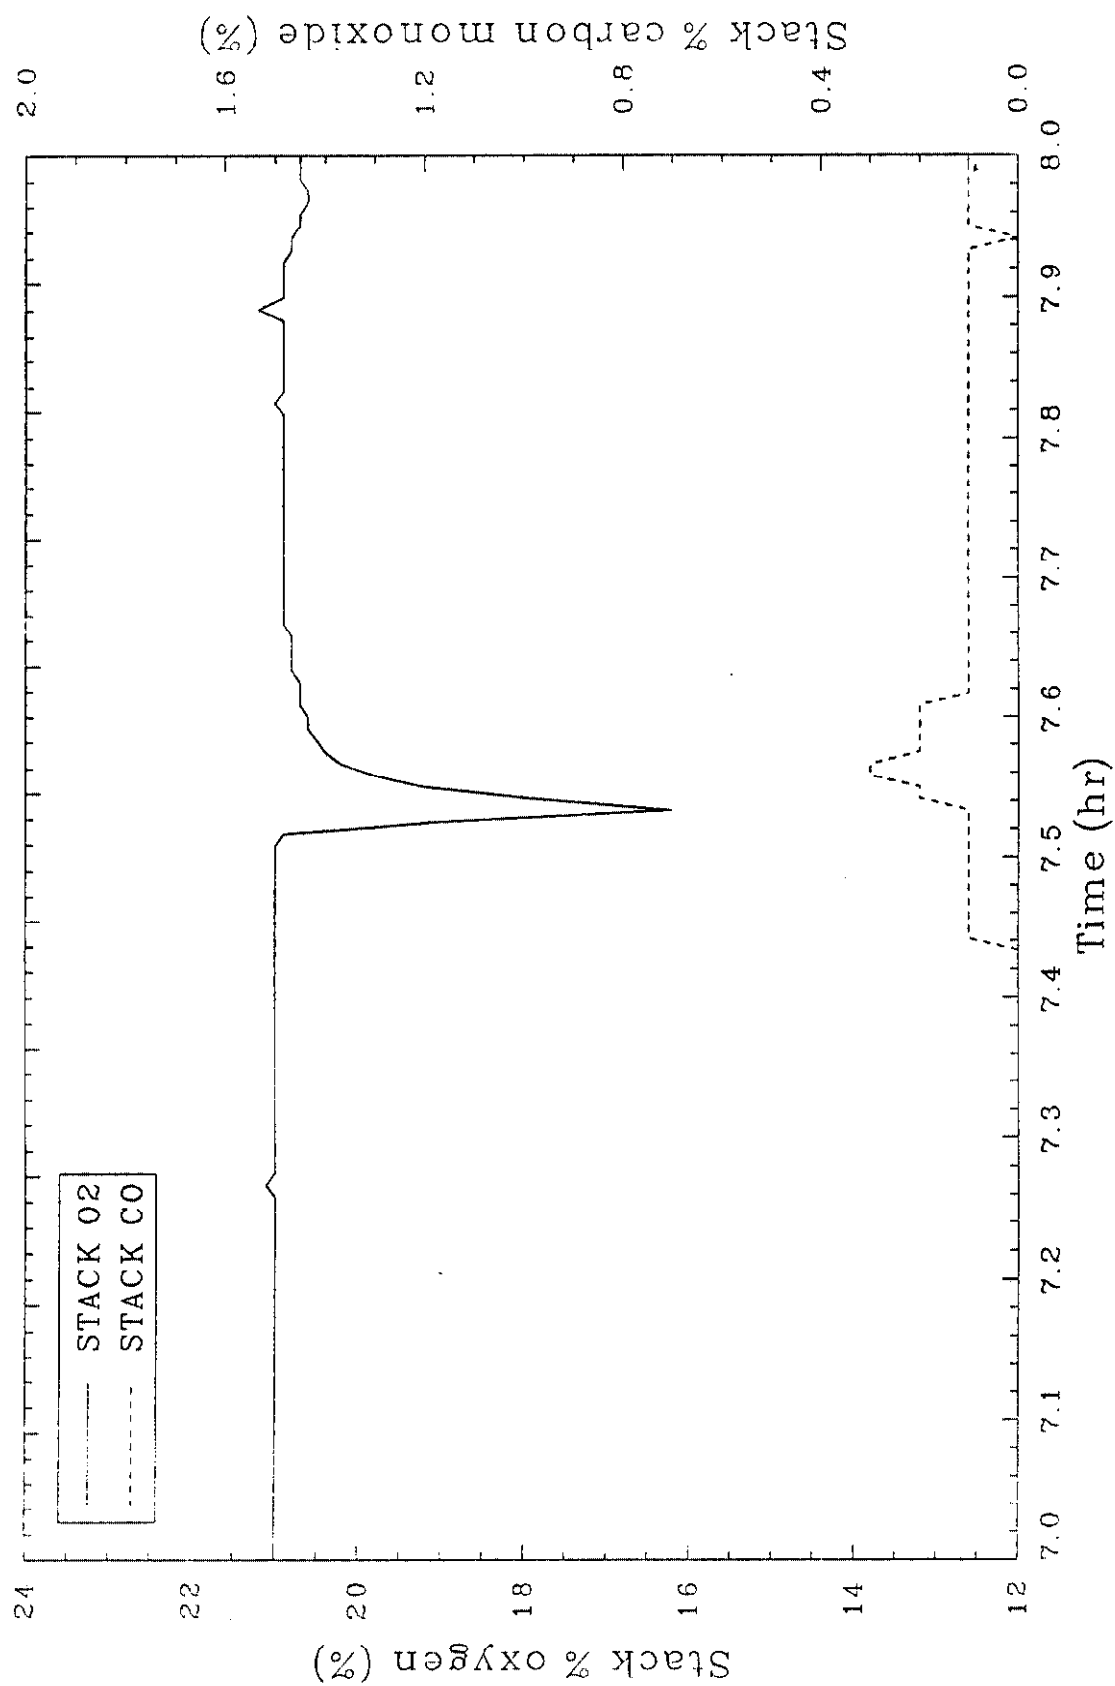
The third event resulted in the stack oxygen concentrations to decrease from 20.9 to 16%, and carbon monoxide values to increase from 0 to 0.3%, shown in Figure 48. These values indicate the gas release resulted in combustion in the hood. An operator observed the event and noticed the hood appeared to be smoke filled. Flares were present.

Figure 48. Stack oxygen and carbon monoxide concentrations for the third event in Test 1.

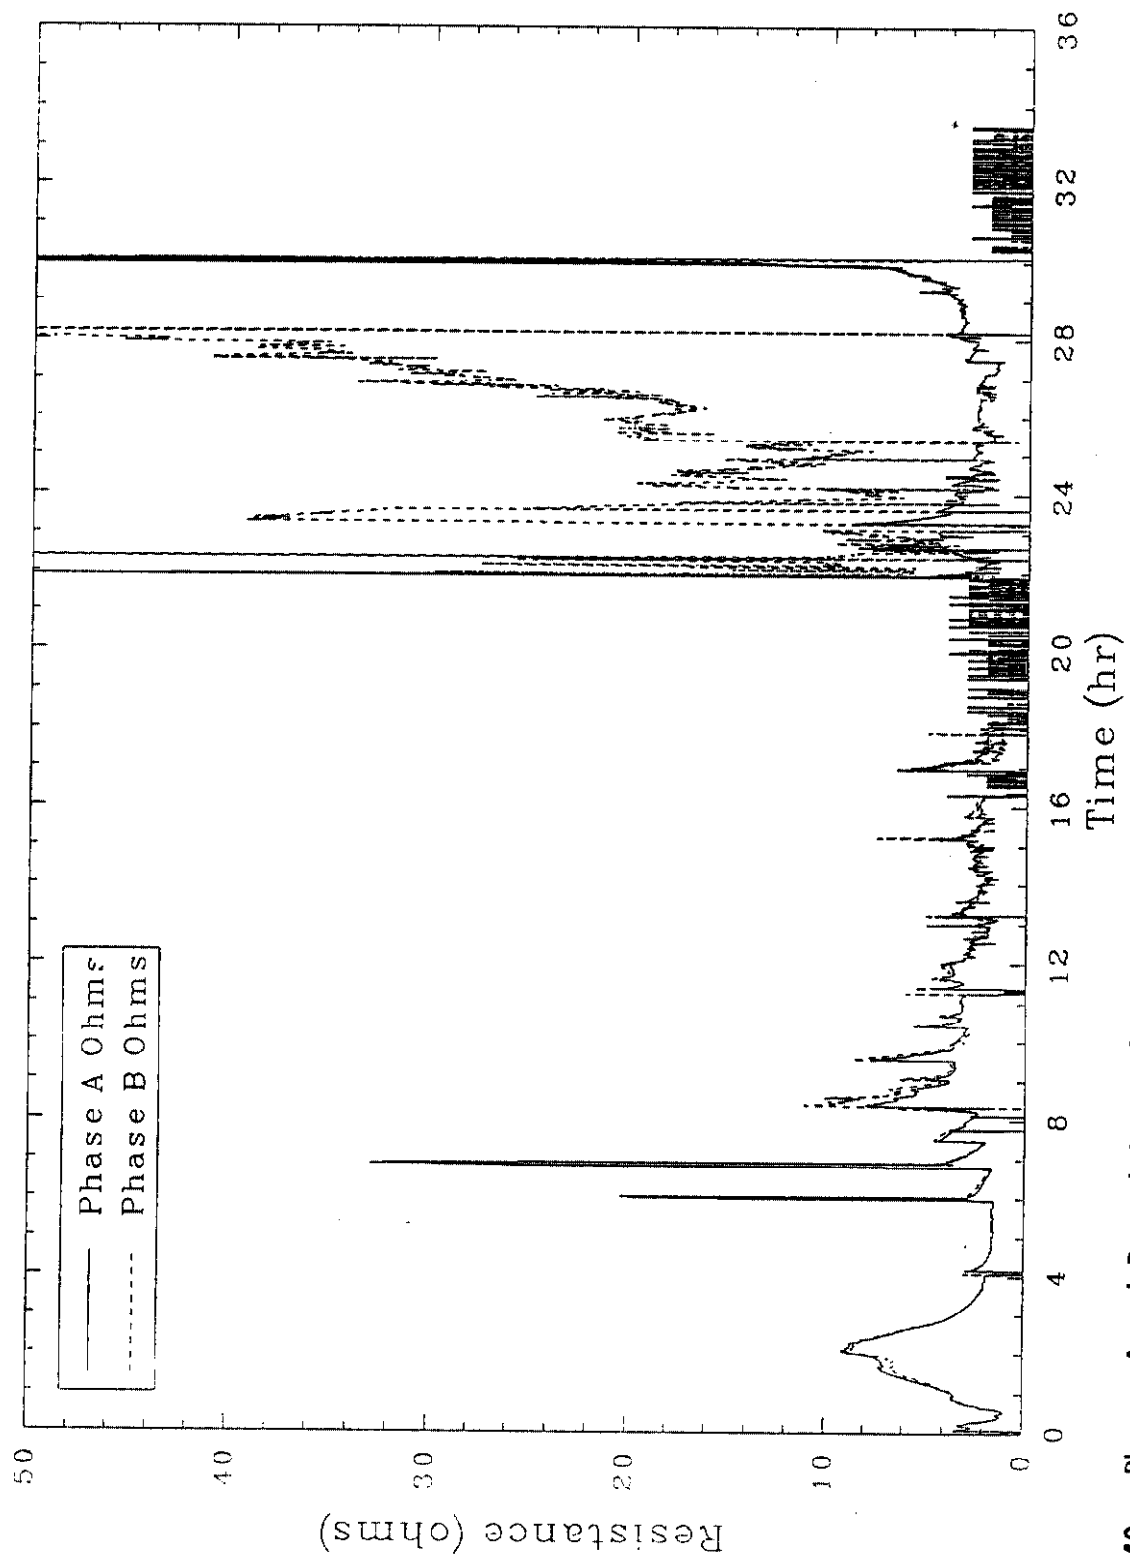
Attempts to replenish the heat to the melt via electrode power through phase A was futile and resulted in localized heating between the phase A electrodes. Phase A resistance gradually increased to 170 ohms, and the glass pool being heated by the phase A electrodes ultimately melted away from the four stuck electrodes. The test was terminated when phase A amperage began to wildly fluctuate while the phase A voltage correspondingly spiked to full-scale. This indicated the advancing melt had finally melted away from at least one of the phase A electrodes. At this point, because the electrodes were frozen in place and no longer in contact with molten glass, electrode power was terminated and preparations for process equipment shutdown were initiated.

Figure 49. Phases A and B resistance for Test 1.
